# Your survey and valuation report

25, Sample Bank, Witham,  
Lincolnshire PE21 7PQ

8th September 2026

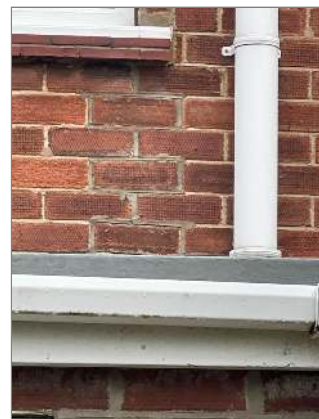
1. The external brickwork is generally in fair condition for its age and the main elevations remain serviceable.
2. Minor cracking is present locally, including around the bay and some openings. More notable cracking was identified to the right-hand side elevation around openings. Previous repointing repairs have been undertaken, although some cracks have subsequently reopened.

3. In my opinion, the cracking is consistent with a degree of historic settlement/movement of the structure. The extent of damage remains relatively minor; however, localised professional masonry repairs, potentially including crack-stitching, are required.

*Photo - 32 Repaired cracks - rear*

4. Some previous repointing is of poor quality and should be properly renewed as part of the masonry repairs.
5. Older properties of this construction commonly have comparatively shallow foundations and can be more susceptible to seasonal ground movement, particularly during prolonged periods of dry weather.

**ACTION:** Undertake repairs and maintenance within an appropriate timescale.

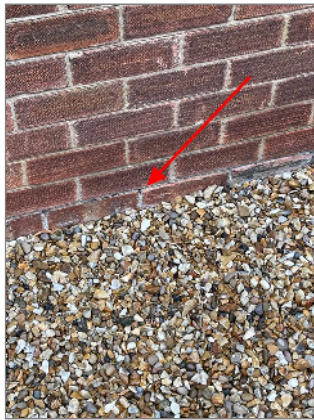
*Photo - 33 Bitumen DPC*

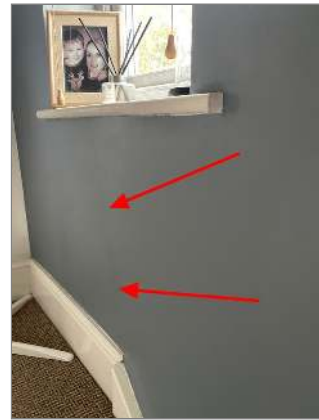
2. A slight plaster crack was noted beneath the side landing window. This broadly corresponds with minor movement noted externally. In my opinion, the cracking is **not structurally significant** and is suitable for localised preparation and a more durable plaster repair before redecoration. Some recurrence remains possible if the underlying minor movement continues.

*Photo - 69 Slight crack landing in line with the slight movement noted side elevation*
