LEVEL 3

# Your survey report

58, Sample Street, Northampton  
NN1 4DJ

9th September 2026

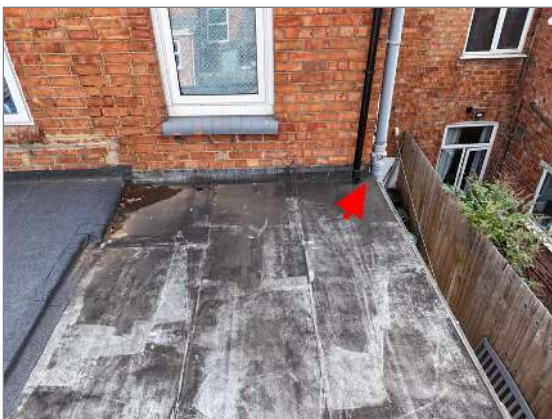
*Photo - 27 Run down pipe into gutter to reduce wear on felt covering.*

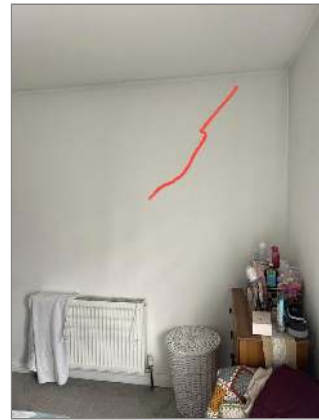
5. **Internal cracking:** Slight plaster cracking was noted, particularly to the right-hand party wall within the front bedroom. In my opinion, this is consistent with minor historic movement and **does not presently indicate significant structural instability**. Repair and monitor during normal redecoration.

*Photo - 86 Minor plaster cracks front bedroom*

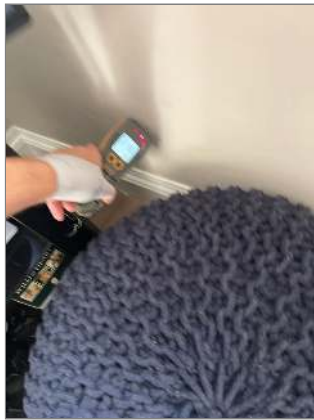
1. **Dampness and ventilation:** Slightly elevated moisture readings were recorded at the base of some ground-floor walls. Evidence of previous chemical damp-proofing was identified. Low-level ventilation to the suspended timber floor/cellar is limited and should be improved, with painted-over/restricted ventilation openings cleared.

*Photo - 91 Higher moisture readings rear dining area*

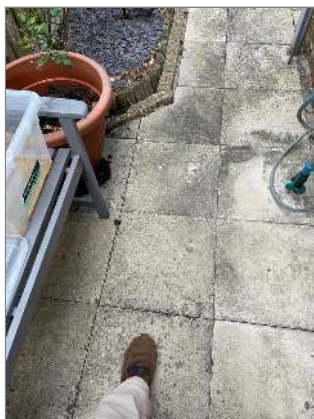
*Photo - 158 Loose paving*

Loose or uneven paving should be re-bedded promptly to reduce trip hazards and maintain effective surface-water falls away from the building.
