# Your survey and valuation report

25, Sample Bank, Witham,  
Lincolnshire PE21 7PQ

8th September 2026

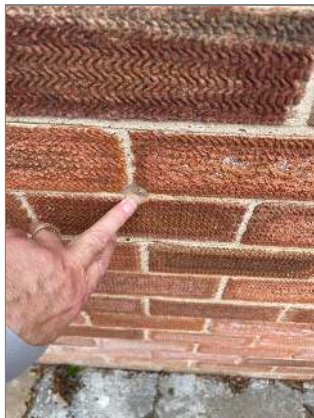
*Photo - 23 Drill hole cavity insulation fitted*

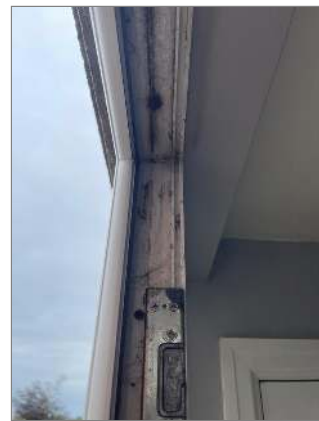
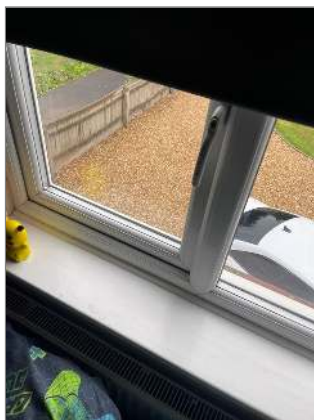
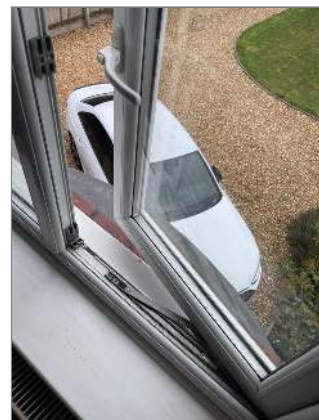
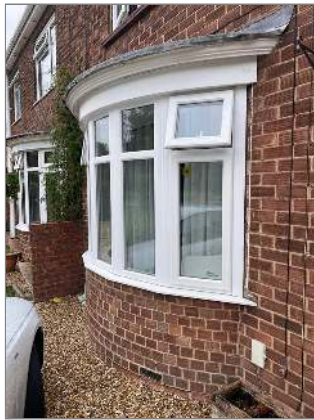
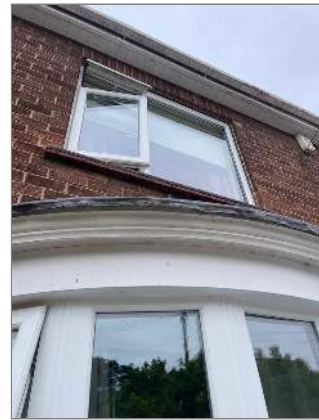
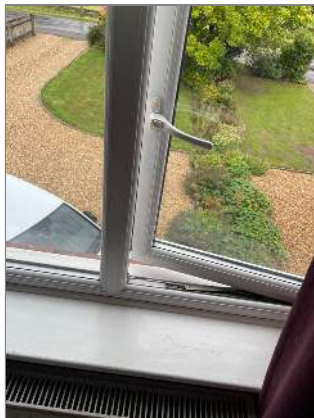
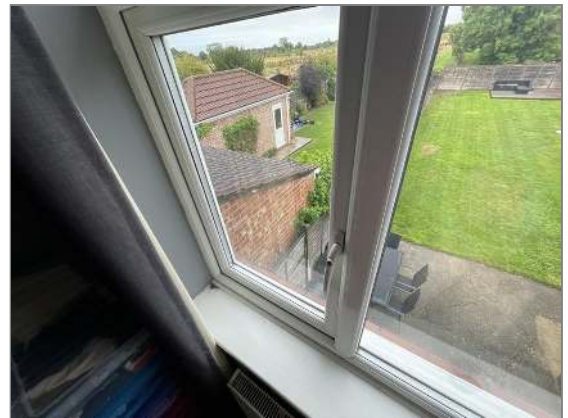
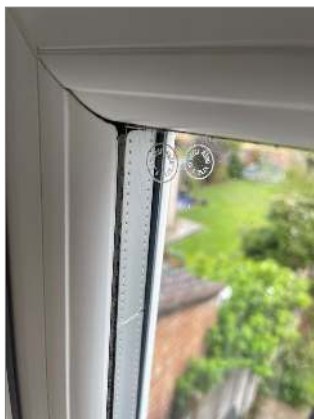
1. The windows are generally in satisfactory condition and the units tested operated normally. Frames, handles and associated fittings appear secure and serviceable.
2. No significant defects were identified to the visible frames or glazing at the time of inspection.
3. Sealed double-glazed units have a finite service life and can fail with age, resulting in condensation or misting between the panes. Individual glazing units should be replaced as failure occurs.
4. Window mechanisms, hinges and locking fittings should be cleaned, lubricated and adjusted periodically as part of normal maintenance.

**Condition Rating 1 – Justification:** No significant defects were identified and the element appears serviceable.

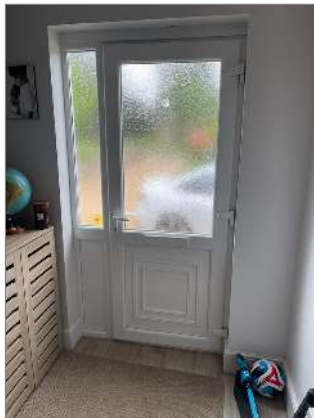
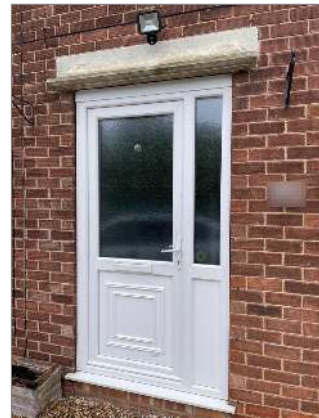
1. The doors are in satisfactory condition and appeared secure and serviceable when operated during the inspection.
2. No significant defects were identified to the visible frames, glazing, hinges or locking mechanisms.
3. Your legal adviser should obtain any available Building Regulation/FENSA certification and transferable guarantees relating to their installation.
4. Door fittings, hinges and locking mechanisms should be cleaned, lubricated and adjusted periodically as part of normal maintenance.
5. As a sensible security precaution, the external door locks should be changed when you take occupation.

**Condition Rating 1 – Justification:** No significant defects were identified and the element appears serviceable.

**ACTION:** Continue routine maintenance and periodic inspection.

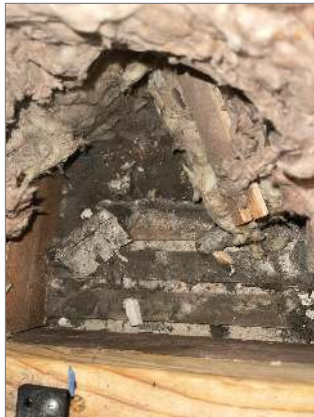
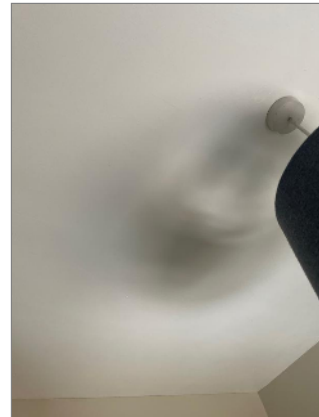
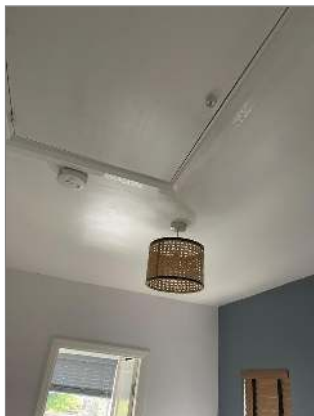
1. The ceilings are generally level, secure and serviceable, with only minor age-related imperfections noted.
2. No significant sagging, displacement, water staining or evidence of widespread ceiling failure was identified.
3. Traditional lath and plaster ceilings become more susceptible to cracking and loss of key with age. Localised repairs should therefore be anticipated during future ownership.
4. In my opinion, no significant repairs are currently required, although older ceiling finishes should be monitored and repaired locally as deterioration occurs.

**Condition Rating 1 – Justification:** No significant defects were identified and the element appears serviceable.

**ACTION:** Continue routine maintenance and periodic inspection.

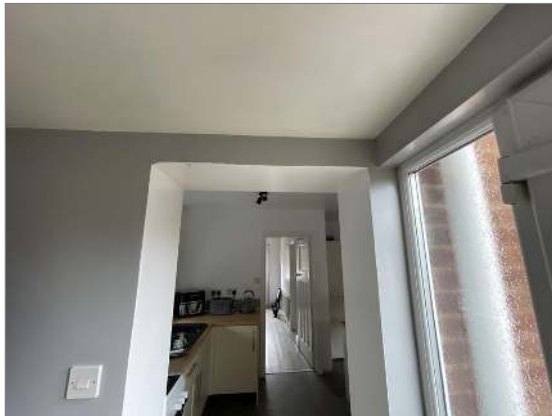
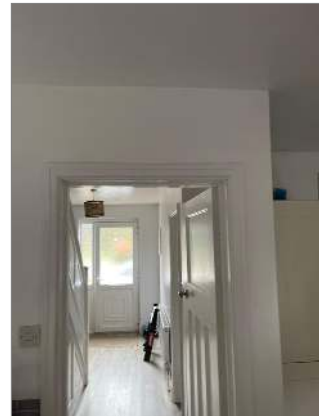
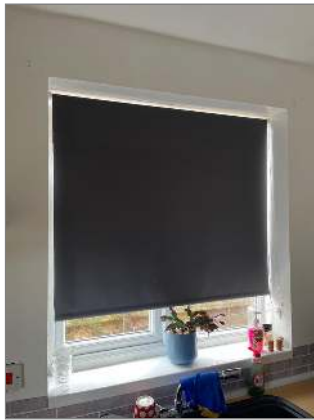
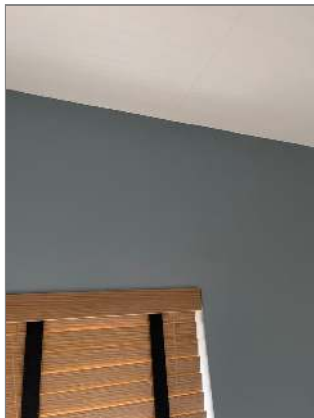
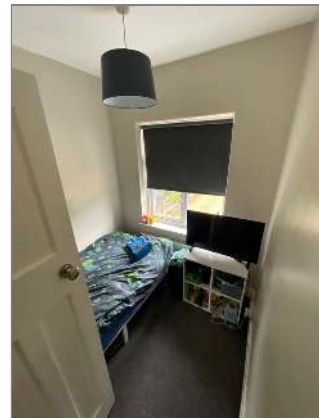
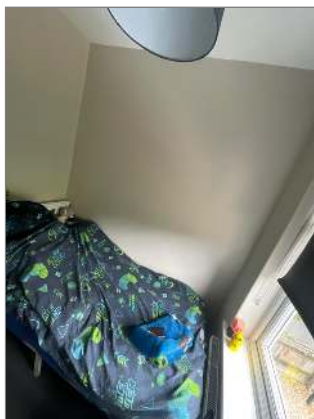
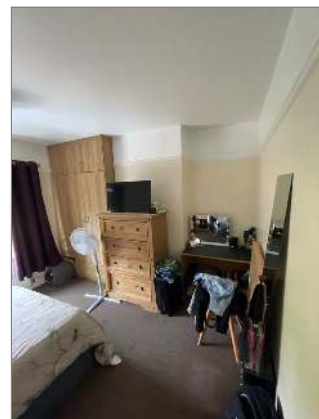
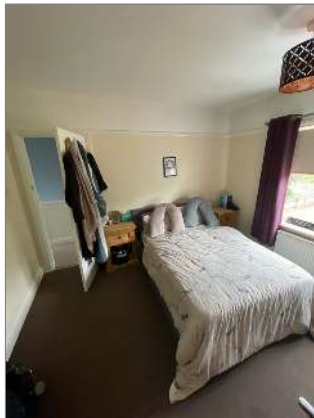
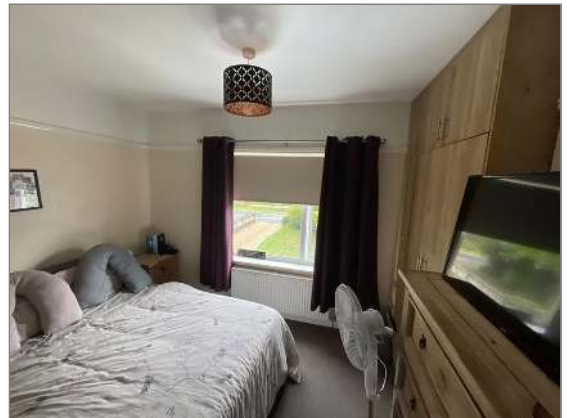
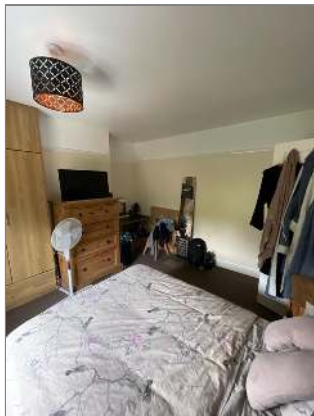
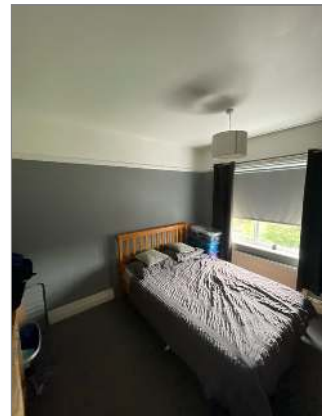
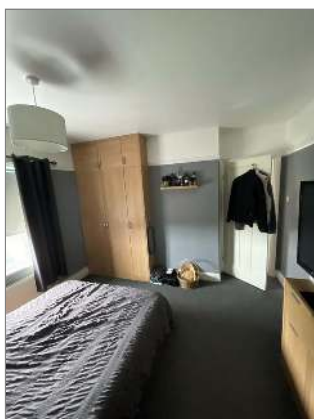
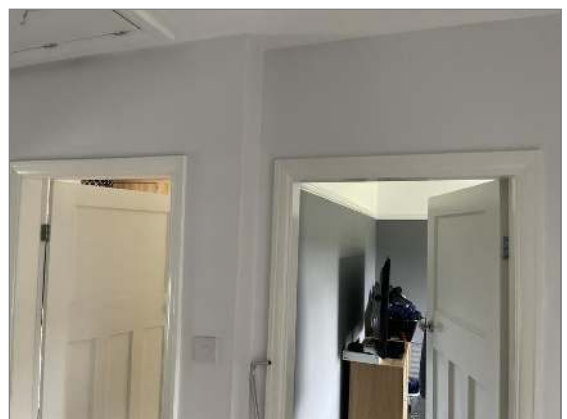
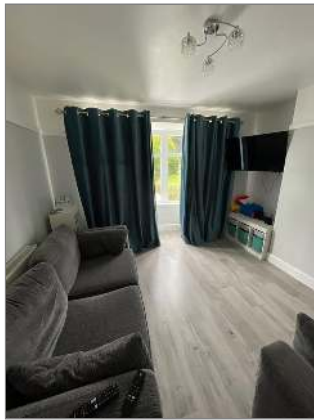
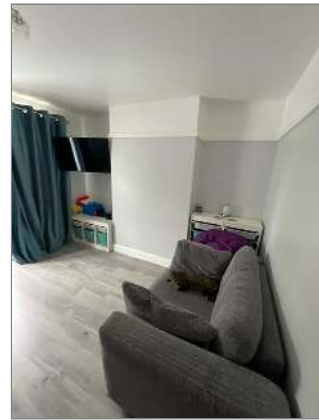
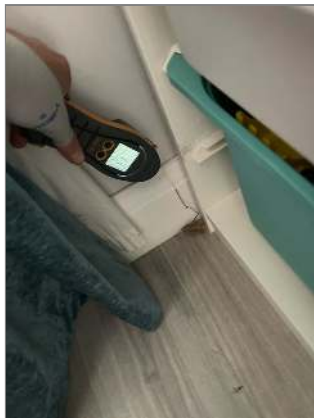
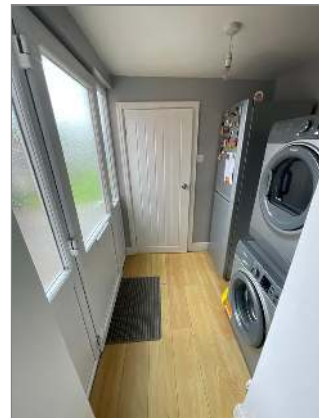
1. The internal wall surfaces are generally in satisfactory condition, with **no significant distortion or other evidence of serious structural movement noted internally**.

2. A slight plaster crack was noted beneath the side landing window. This broadly corresponds with minor movement noted externally. In my opinion, the cracking is **not structurally significant** and is suitable for localised preparation and a more durable plaster repair before redecoration. Some recurrence remains possible if the underlying minor movement continues.

4. Isolated slightly elevated moisture readings were recorded at low level with an electronic moisture meter. These were limited in extent, with no associated significant deterioration to the internal finishes. In my opinion, the findings do not indicate an immediate significant damp problem, although the affected areas should be monitored.

**Condition Rating 2 – Justification:** Supporting documentation, approvals or certification were unavailable but the issue is not considered purchase-critical.

**ACTION:** Obtain documentation through your legal adviser.

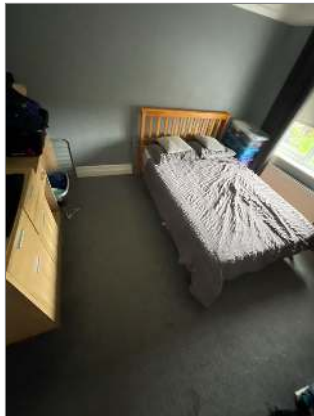
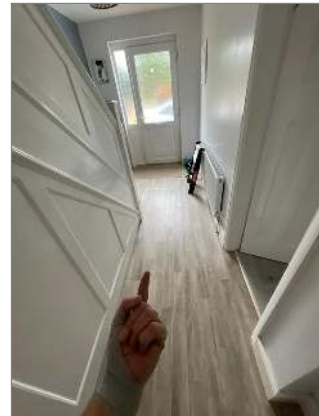
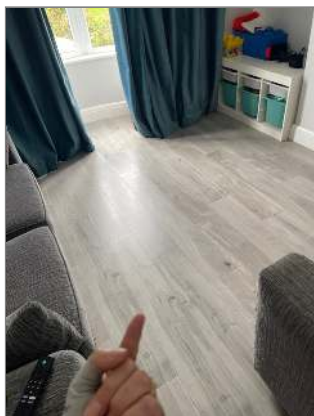
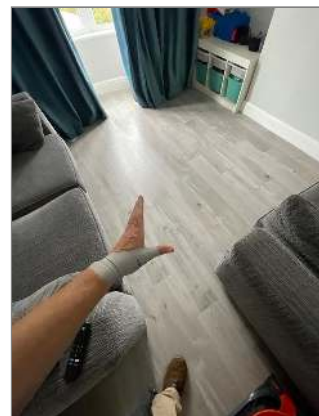
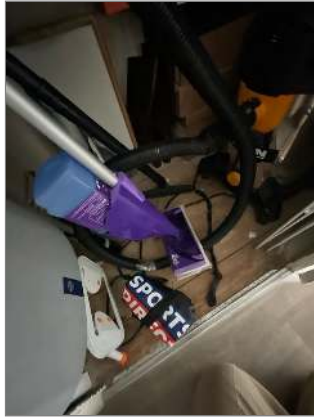
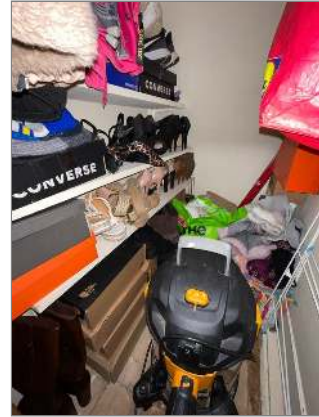
1. The floors generally felt firm and serviceable underfoot, with no significant deflection, springing or unevenness noted in the accessible areas. Normal minor creaking was noted.

2. No evidence of significant structural floor failure was identified during the inspection.
3. Fitted floor coverings and furnishings prevented detailed inspection of the underlying floorboards and structural timbers. Floorboards were not lifted.

**Condition Rating 1 – Justification:** No significant defects were identified and the element appears serviceable.

4. In properties of this age, floorboards are commonly disturbed during plumbing, heating and electrical alterations and are not always adequately re-secured. When the floor coverings are next lifted or replaced, the boards should be checked and any loose or inadequately fixed boards securely refixed.

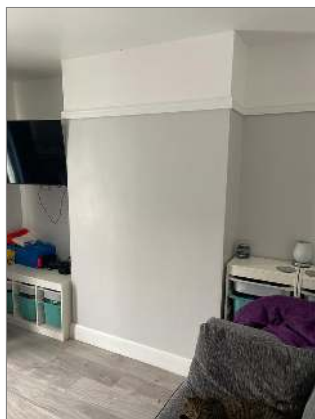
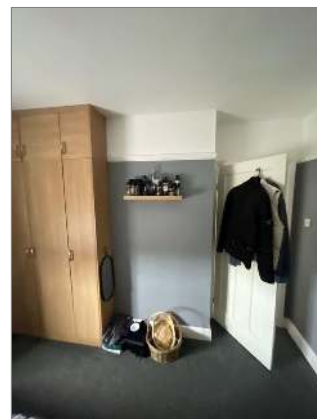
1. No significant cracking, distortion or other evidence of structural distress was identified internally around the areas of the removed chimney breasts.

4. The flues were not smoke tested and their internal condition cannot be confirmed. They should not be brought back into use without prior inspection and testing by an appropriately competent contractor.

**Condition Rating 2 – Justification:** Supporting documentation, approvals or certification were unavailable but the issue is not considered purchase-critical.

**ACTION:** Obtain documentation through your legal adviser and arrange ventilation improvements within an appropriate timescale.

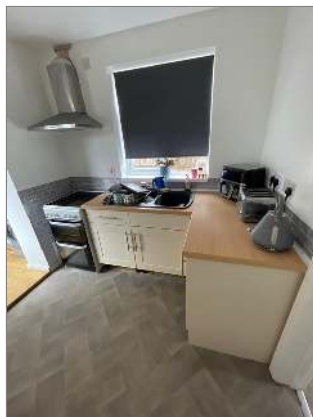
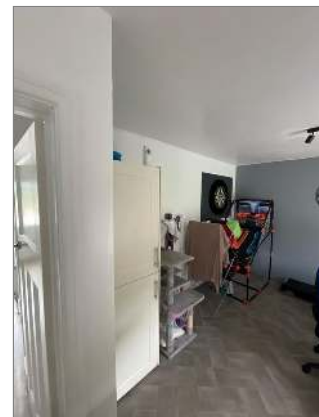
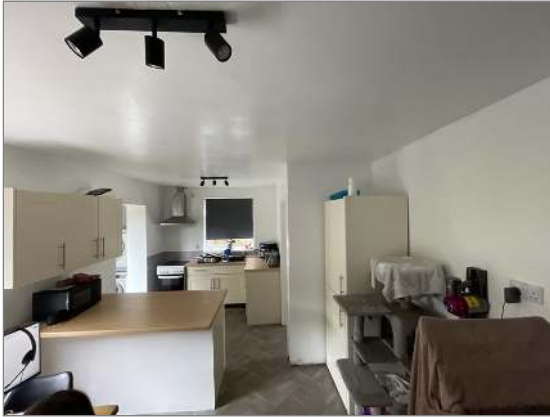
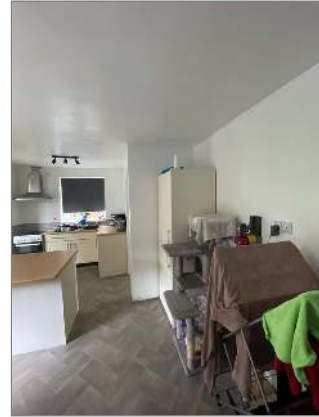
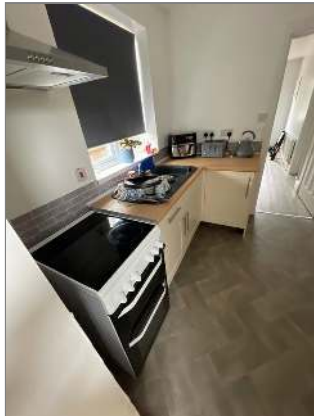
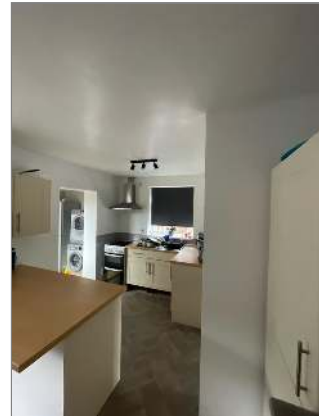
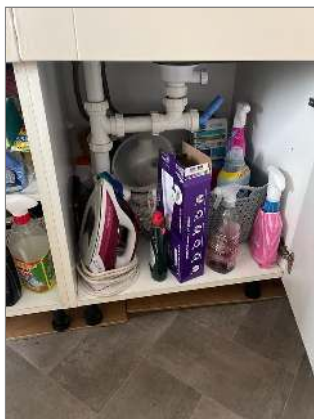
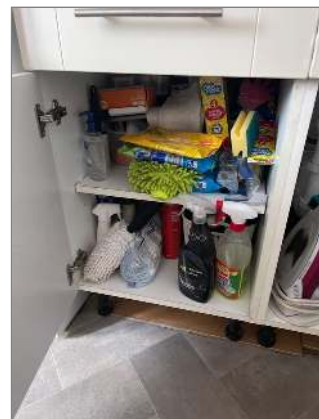
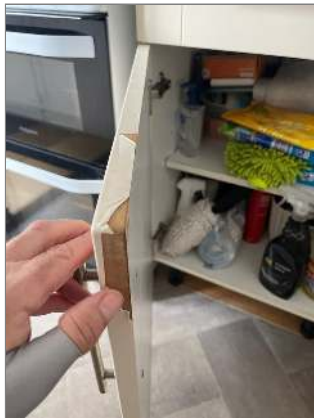
1. The kitchen remains functional and usable but the fittings are generally worn and tired. There is localised damage to cabinet doors and finishes, together with missing sections of plinth/kickboard beneath the base units.
2. Some doors and fittings require adjustment or repair. Missing plinths should be reinstated and damaged components repaired or replaced.
3. In my opinion, the kitchen is approaching the stage where general refurbishment or replacement should be anticipated.
4. No significant leakage was evident beneath the sink at the time of inspection.
5. Built-in and freestanding appliances were not tested as part of this inspection.
6. Allow a budget for repairs in the short term and more comprehensive kitchen refurbishment according to your requirements.

**Condition Rating 2 – Justification:** Age-related deterioration, wear and maintenance requirements were identified.

**ACTION:** Undertake repairs and maintenance within an appropriate timescale.

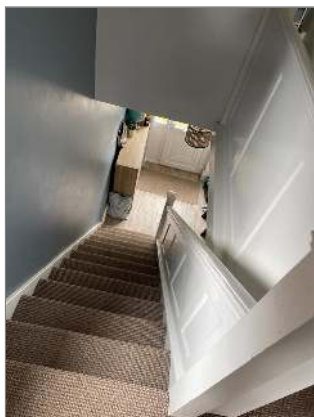
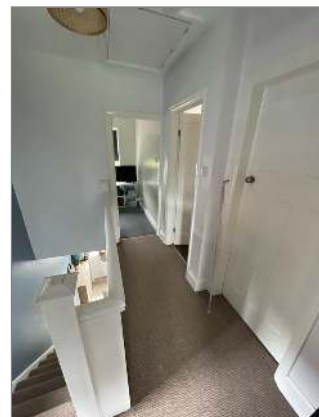
1. The staircase is generally firm, secure and serviceable, with no significant defects noted during normal use.
2. Internal doors and the majority of associated joinery are in satisfactory condition for their age.
3. Some minor wear and deterioration is present, consistent with normal occupation.
4. Some sections of timber trim/fittings are missing within the kitchen area and should be reinstated as part of routine repair and refurbishment.
5. Painted timberwork will require periodic redecoration and minor repairs as part of normal maintenance.

**Condition Rating 1 – Justification:** No significant defects were identified and the element appears serviceable.

**ACTION:** Continue routine maintenance and periodic inspection.

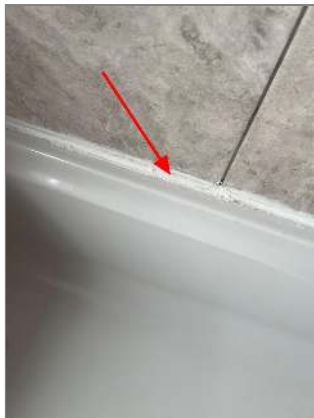
1. The sanitary fittings are generally functional and serviceable but show normal wear consistent with their age.
2. The sealant around the bath is deteriorated and poorly finished in places. In my opinion, this should be renewed to provide an effective watertight seal, particularly where the bath is used as a shower.
3. Defective seals can allow water to penetrate behind the bath and wall finishes, resulting in concealed dampness and deterioration.
4. The mechanical extractor fan is an older installation. It should be maintained and checked for satisfactory operation, with upgrading considered if its performance is inadequate.
5. Routine maintenance and local refurbishment of the bathroom fittings and finishes should be anticipated.

**Condition Rating 2 – Justification:** Repairs and maintenance are required to the bath seals and associated finishes, but there is no indication from the inspection photographs of a defect requiring urgent or immediate repair.

*Photo - 108 Poor bath seals*

**ACTION:** Renew the defective bath sealant and check the surrounding junctions for watertightness. Maintain the sanitary fittings and check the extractor fan for effective operation.

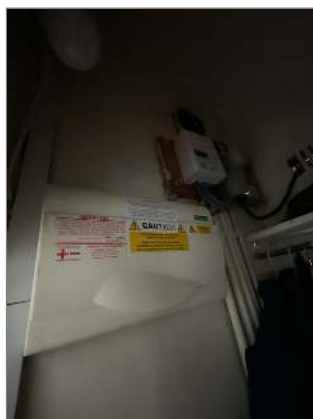
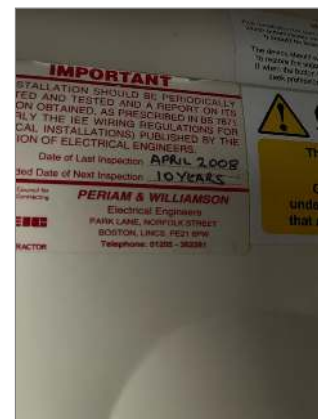
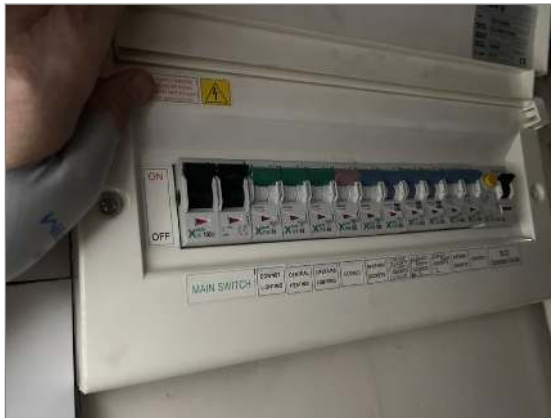
1. The consumer unit is an older installation but no significant visible damage was noted.
2. The inspection label records that the electrical installation was last inspected in April 2008, with the next inspection due after 10 years.
3. No evidence of a more recent electrical inspection and test was available at the time of survey.
4. In my opinion, the installation is now overdue for inspection and testing. A suitably qualified registered electrician should undertake an Electrical Installation Condition Report (EICR) and carry out any necessary remedial work.
5. Your Legal Adviser should check whether the vendor holds a more recent electrical inspection and test certificate.

**Condition Rating 2 – Justification:** The electrical installation is overdue for inspection and testing and further investigation is required.

**ACTION:** Arrange inspection and testing by a registered electrician and obtain costings for any necessary repairs before exchange of contracts.

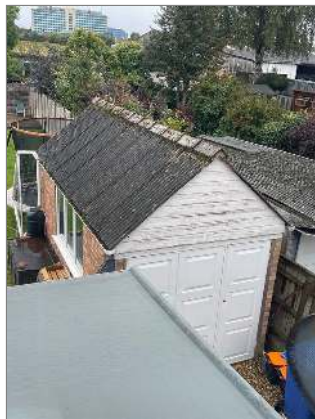
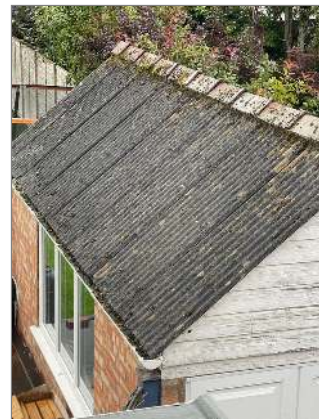
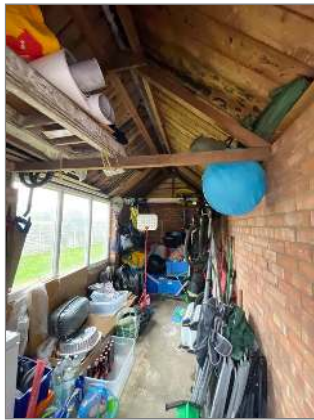
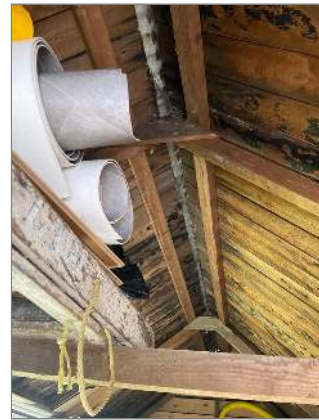
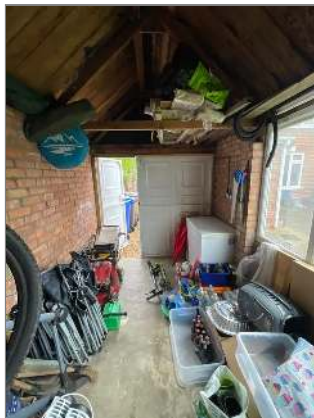
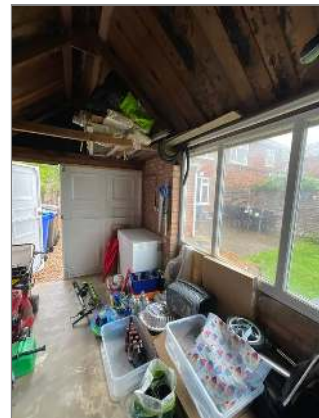
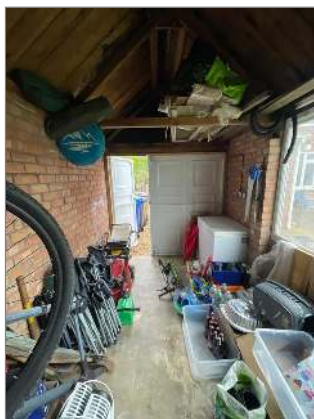
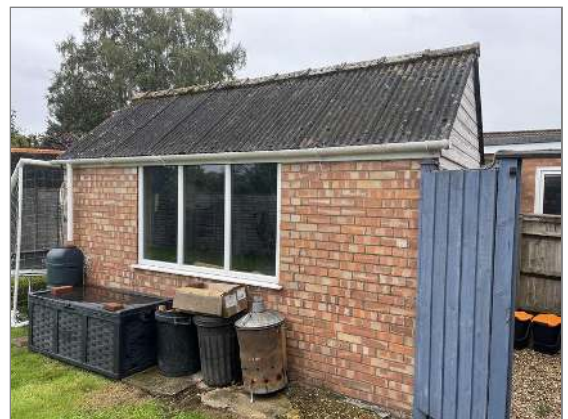
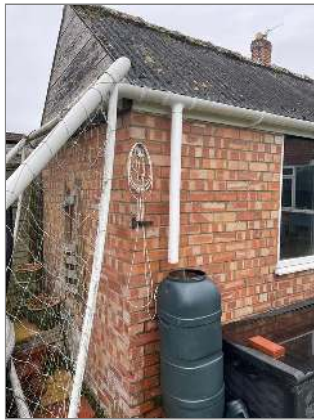
1. The main structure of the garage is generally serviceable for its age and type.
2. The corrugated fibre-cement roof covering is weathered and deteriorating, with moss/lichen growth and general age-related wear evident.
3. In my opinion, the roof sheets are likely to contain asbestos. They should not be cut, drilled, sanded or otherwise disturbed without appropriate precautions.
4. The roof covering is approaching the stage where renewal should be anticipated. Before carrying out work, an asbestos survey/testing should be undertaken by a suitably competent specialist to confirm the material and advise on safe removal and disposal.
5. The timberwork and external joinery are weathered and will require routine repair, preparation and redecoration.
6. The garage was heavily occupied with stored contents, which restricted inspection of parts of the walls, floor and structure.

**Condition Rating 2 – Justification:** The garage remains serviceable, but the roof covering is deteriorating and future renewal should be anticipated. The suspected asbestos-containing roof sheets also require appropriate specialist precautions before they are disturbed or removed.

**ACTION:** Arrange for the roof sheets to be sampled or assessed by a competent asbestos specialist before undertaking repairs or replacement. Budget for future renewal of the roof covering and carry out routine repairs and redecoration to the timberwork.

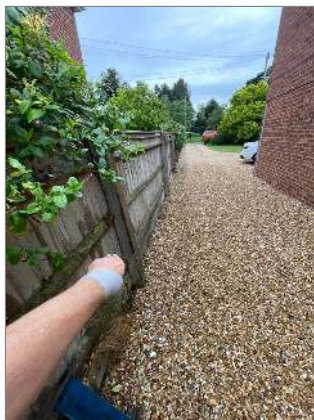
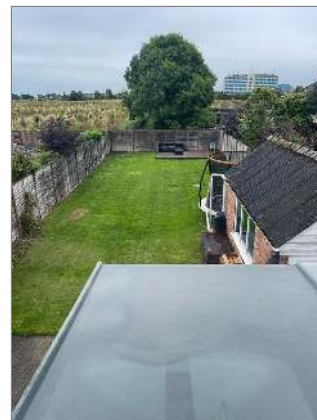
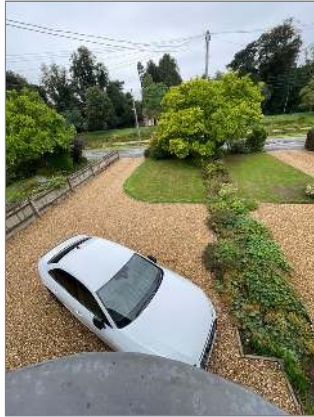
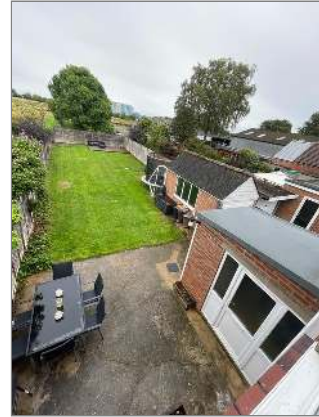
3. The lawns, planted borders, shrubs and other vegetation are generally maintained.
4. Sections of the right-hand boundary fencing are leaning and locally out of alignment. In my opinion, some posts and/or fixings are likely to require strengthening, refixing or replacement. The fencing should be checked for stability and repaired as necessary.

5. Other visible boundary fencing is generally serviceable, although normal periodic maintenance and localised repairs should be anticipated.
6. Trees and larger shrubs should be maintained at a reasonable size and kept clear of the building, drainage runs and neighbouring property.

**Condition Rating 2 – Justification:** Age-related deterioration, wear and maintenance requirements were identified.

**ACTION:** Undertake repairs and maintenance within an appropriate timescale.
