LEVEL 3

# Your survey report

58, Sample Street, Northampton  
NN1 4DJ

9th September 2026

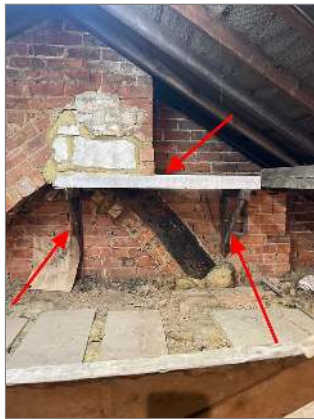
1. The accessible roof structure was generally serviceable with no excessive sagging or displacement noted.
2. Additional timber strengthening has been installed to the roof structure.
3. Felt lining is present beneath the tiled roof covering.
4. No active roof leaks were noted at the time of inspection.
5. Staining was noted within the roof space, consistent with possible historic condensation.
6. Ventilation to the roof space is limited.
7. The roof structure over the bathroom was not accessible for inspection.
8. The rear chimney breast has been removed and the retained masonry above is supported on a steel gallows bracket.

*Photo - 66 Support for chimney breast*

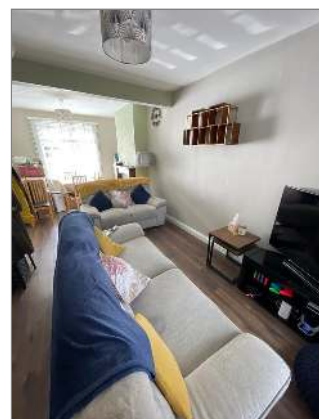
*Photo - 90 Lounge opened up and chimney breast removed.*

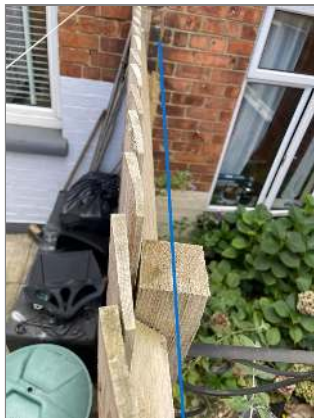
*Photo - 156 Correct boundary line?*
