LEVEL 3

# Your survey report

58, Sample Street, Northampton  
NN1 4DJ

9th September 2026

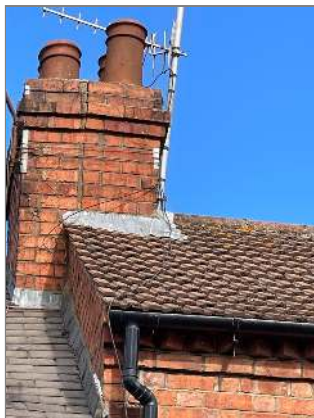
Photo - 8

1. The chimney stack is generally serviceable with no significant leaning or displacement noted.
2. Deterioration of the cement flaunching was noted.
3. Rain cowls are not fitted to the chimney pots.

**Condition Rating 2** has been applied because deterioration of the chimney flaunching requires repair, together with upgrading of the chimney pots, but the defects are not considered serious or urgent.

Repair or renew the defective flaunching and consider fitting suitable rain cowls to the chimney pots.

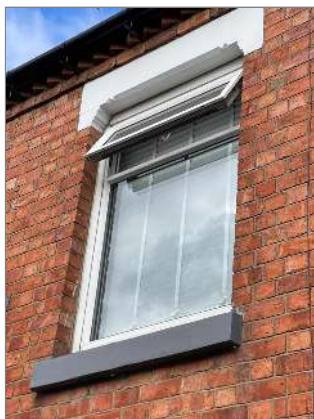
The first-floor bedroom window openings do not meet current standards for means of escape and upgrading should be considered as part of future window replacement.

*Photo - 62 Restricted opening size*

- Replace the failed sealed double-glazed unit to the front bedroom window.
- Budget for progressive upgrading or replacement of the older windows.
- Consider upgrading the first-floor bedroom windows to provide suitable means of escape.

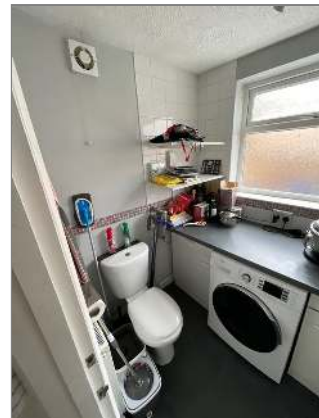
*Photo - 93 Rear opened up - kitchen to cloaks*

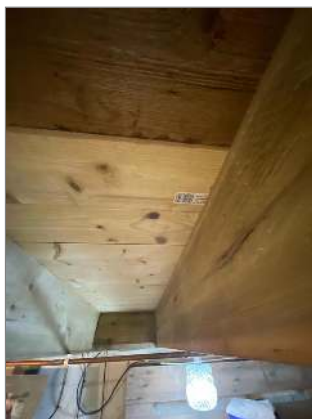
*Photo - 131 Past wood worm floor yimbers seen in cellar.*

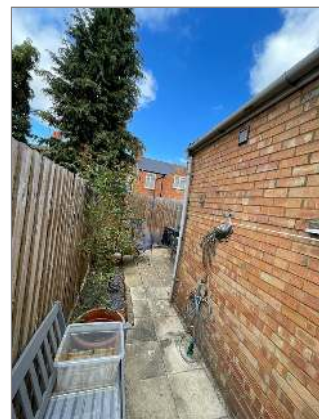
*Photo - 158 Loose paving*

Loose or uneven paving should be re-bedded promptly to reduce trip hazards and maintain effective surface-water falls away from the building.
